Application of Lock-In Thermography for Detecting Leakage Defects in Historic Masonry Arch Structures

Abstract: Defects in masonry are difficult to detect with the naked eye. Non-destructive testing (NDT) techniques are one such ways to detect defects. One way to detect moisture is by using lock-in Infrared (IR) thermography technology. The main objective of this research is to detect a defect in masonry brick walls using infrared thermography camera. Infrared thermography tests were conducted in the laboratory on several experiments to understand time and temperature relationships. Tests were conducted on a masonry water tank with a known defect spot and were successfully detected from the thermography images. Two active approach methods were conducted: halogen lights and a heat gun. It has been shown that when using the heat-gun it is a quicker method according to the results. All procedures and methods performed in this report could be useful for field studies.

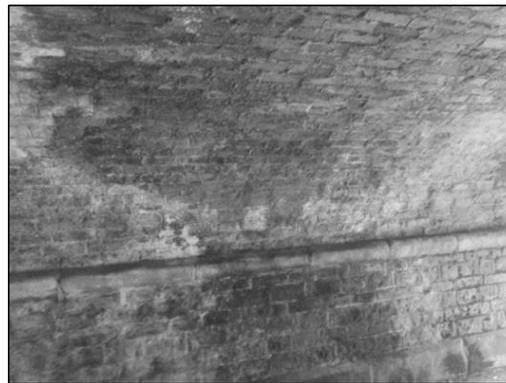
Figure 1: Defect in masonry arch bridge (The Arboretum, Nottingham)

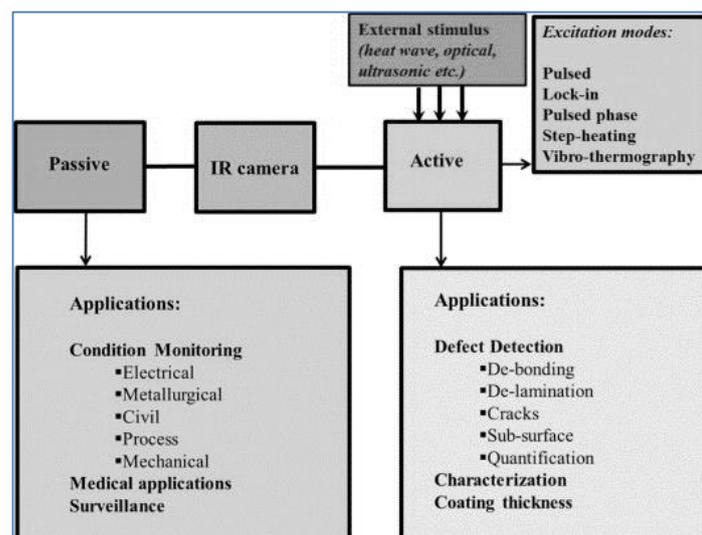
Figure 2: Active and Passive thermography (Bagavathiappan, et al., 2013)

Passive approach: In the applications mentioned for the passive approach, any unusual temperature profiles designate a potential problem to work on and to fix. The technique is established by using solar radiation, this is done to collect and record the thermal images without external system of heating or cooling applied to the object (Stimolo, 2003).

Active approach: This method is divergent to the passive approach. For this approach, an external heater or cooler is required to produce related temperature differences that are non-present otherwise. With the known features of the external stimulus, it gives the opportunity to have quantitative description (Poksinska, 2007).

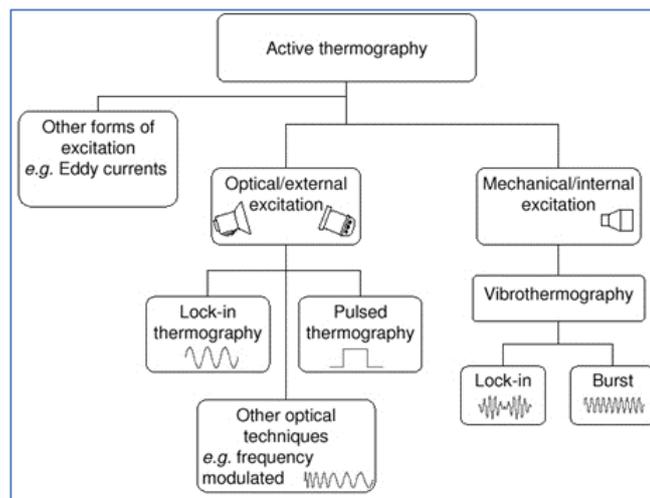
Figure 3: Active thermography (Maldague, 2007)

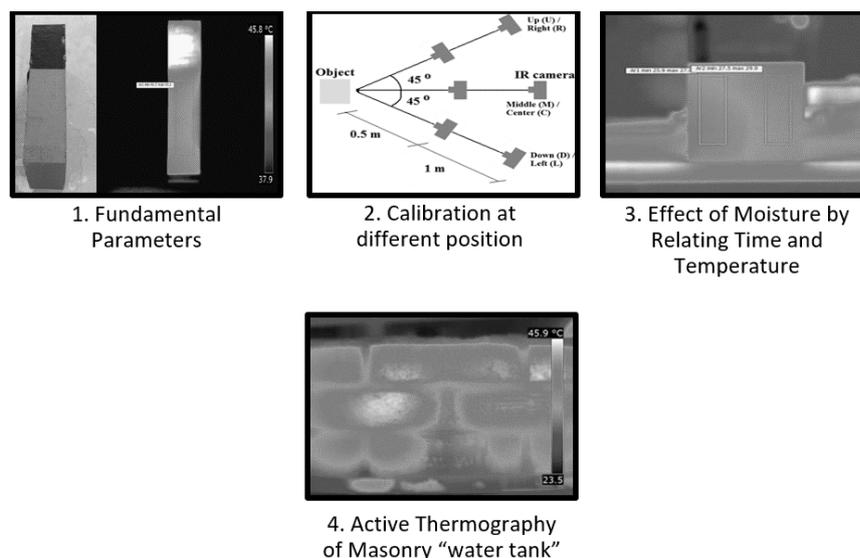
Figure 4: Methodology process

The type of camera that was used was a FLIR-B 360 series. Figure 4 presents the steps taken to achieve the objectives.

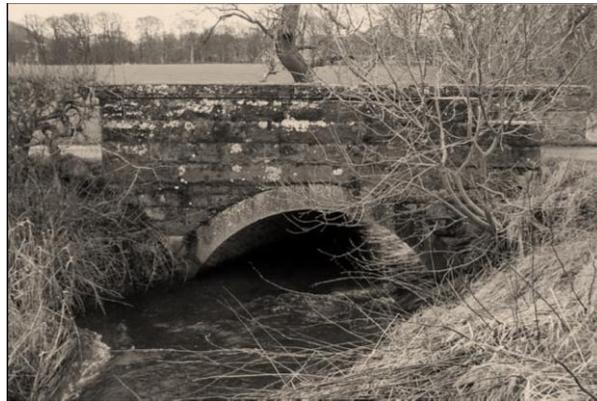
Figure 6: Inaccessible Masonry Bridge from beneath (Glasgow, UK)

In practical life (in-situ), taking thermo images by an IR thermography camera cannot always be taken at any place desired. For example, taking images under a bridge in which beneath a river flows, the

person must stand beside the bridge at an angle to capture the necessary images. An example of such case is illustrated in Figure 6.

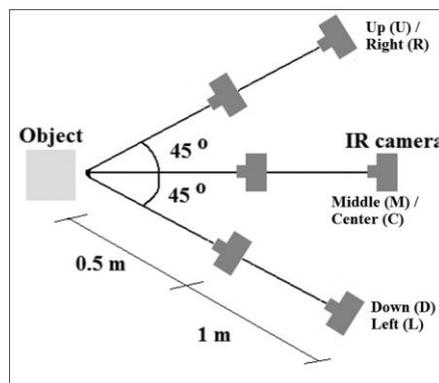
Figure 7: Top and Side view of images captured by IR camera (18 images) Time and temperature relationship.

For this instance, an evaluation has been carried out in the laboratory to understand if the same surface temperature indicated from the IR thermography camera changes of a particular object at different positions. Figure 7 illustrates where the different images has been taken. To evaluate the surface temperature obtained from the IR thermography camera, the images were captured at different angles and distances away from the object.

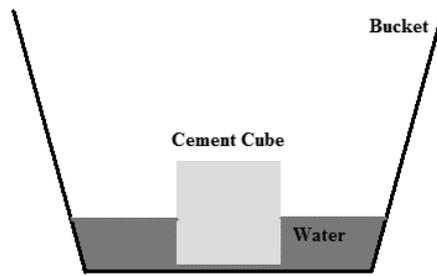
Figure 8: Cement cube in bucket

To evaluate the time and temperature relationship, the active approach using the lock in thermography has been done on cement cubes. Four cement cubes sizes of 10 x 10 x 10 cm have been used in the assessment. All four cubes were kept for 24 hours in a bucket of water. The water level in the bucket was kept a little lower than half the height of the cubes. This was done to have half of the cube to be fully in moisture and the other half (fully) dry. Three of the four cubes were kept in room temperature and one of them was kept in cold water and in a cooler to have a colder temperature. Figure 8 illustrates how the cubes were kept in the bucket.

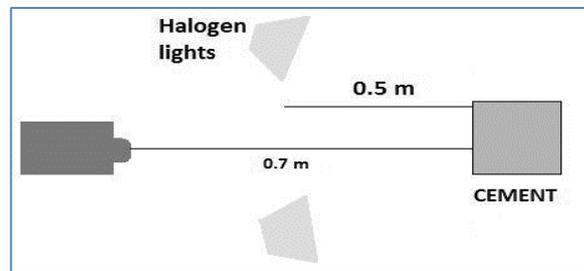
Figure 9: Cement cube tested

Each cube was then taken and assessed using the IR thermo imaging camera. The cubes were investigated in the laboratory under its environmental conditions. The cubes were externally heated up with two halogen lights with each having 500 watts at 0.5 m as illustrated in in figure 9. The IR thermography camera was kept at 0.7 m.

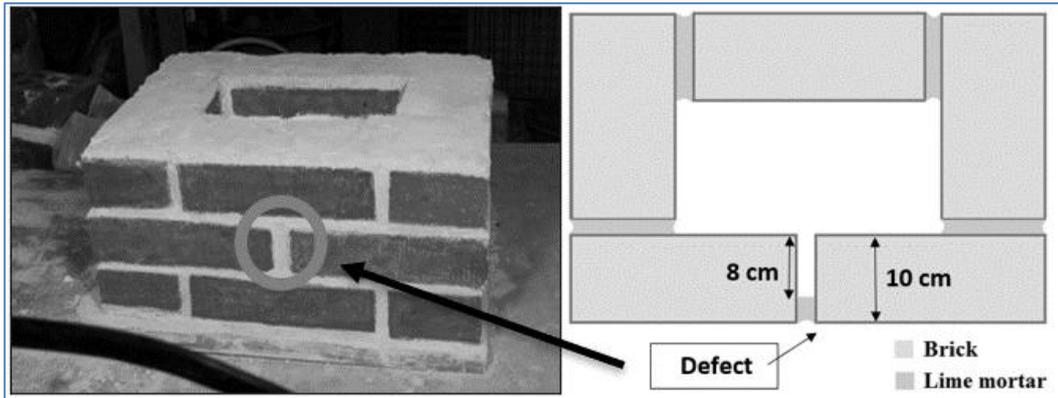
Figure 10: Masonry water tank

Many masonry walls have leaking’s due to cracks in the brick or in the mortar between the bricks. Also, leaks could be caused by poor workmanship at the time it was constructed; by not keeping enough mortar between the bricks causes the water to infiltrate through the mortar and cause leaks. Such leaks cannot be easily found with the naked eye. However, a wall which is moisturized has a lower temperature than the dry side. Although, when a defect is present, the water that infiltrated through the defect normally spreads all over the area, which makes it unable to detect where it is exactly leaking. Figure 1 clearly shows the wet area and the dry area. Nevertheless, it is unable to detect the defect with the naked eye. For this reason, a masonry water tank has been constructed in the laboratory with a known defect. The masonry water tank is illustrated with the indicated defect in Figures 10 & 11.

The tank is built in such a way so that the water can easily infiltrate through the 2 cm thick defect. All measurements and parameters of this report are to be considered and corroborated. To apply the lock in thermography method, two approaches will be done on the masonry water tank to excite the surface temperature with heat to dry up the surface:

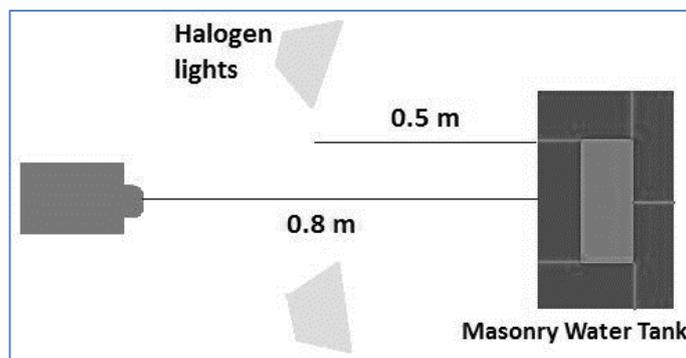
Figure 11: Halogen lights method set-up

In this method, two halogen lights with each having 500 watts of power will be set 0.5 metres away from the masonry water tank and the IR camera will be put 0.8 metres away from the masonry water tank. The procedure will be done in a way that an image is captured every minute until a picture will show justifiable results to be able to trace the defect by a qualitative way. The arrangement has been show in Figure 11.

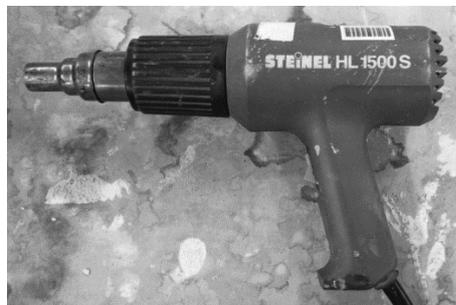
Figure 12: Air Gun

In this method, an ordinary hot air gun (Figure 12) will be used to heat up the surface to get the full surface dry. Since the device has a small diameter for the air flow coming out of the gun, the user must come close to the surface (3 ~ 5 cm distance). The speed to heat up the surface is recommended to be 2 cm/second, this ensure the surface to be fully dry without causing any damage to the device itself or maybe the wall. However, it is recommended to heat the brick area first then the joints between the brick. Heating the bricks takes less time and dries up quicker than the lime. The assessment will be done somewhat different then the first method with the halogen lights. In this case the tank is first fully wet for 24 hours room temperature water. The hot air gun is then applied over the whole surface for approximately 4 minutes making the whole surface fully dry. At last, the tank is let to be cooled down. For each of these three phases an image will be captured with the IR thermography camera. In each image a line segment will be on the vertical joints between the bricks. The lines segments are then transformed to an excel spread sheet and plot into graph to differentiate between time and temperature in three phases: i.e. wet, heating, cooling.

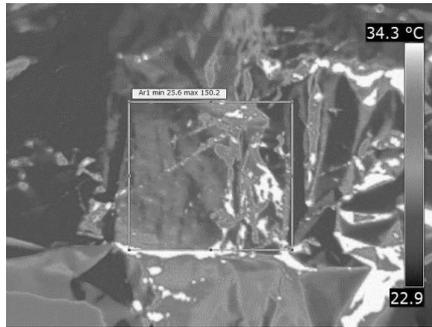
Figure 13: Thermo image of aluminium foil

From the thermo image captured (Figure 13), the procedure is done by using the FLIR QuickReport software included with the camera. The reflected apparent temperature has been found to be 28.5 °C.

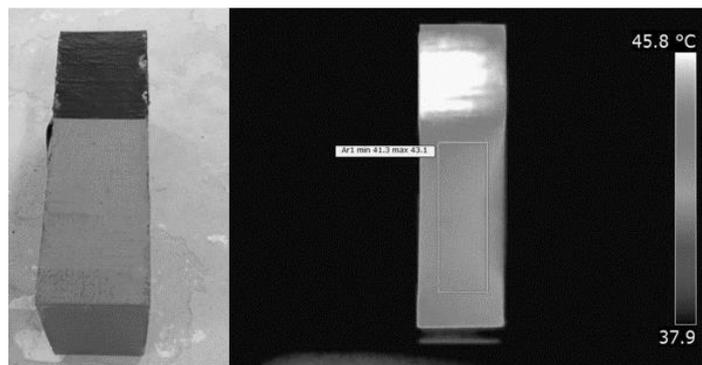
Figure 14: Prepared sample with black tape (left), Captured image of masonry brick to find its emissivity using FLIR QuickReport (right)

This procedure has been carried out for three materials: cement, lime, and masonry brick.

All three samples have been heated up at least 20 °C above room temperature using to halogen lights of 500 watts each. The following table shows the emissivity values obtained from the laboratory assessment:

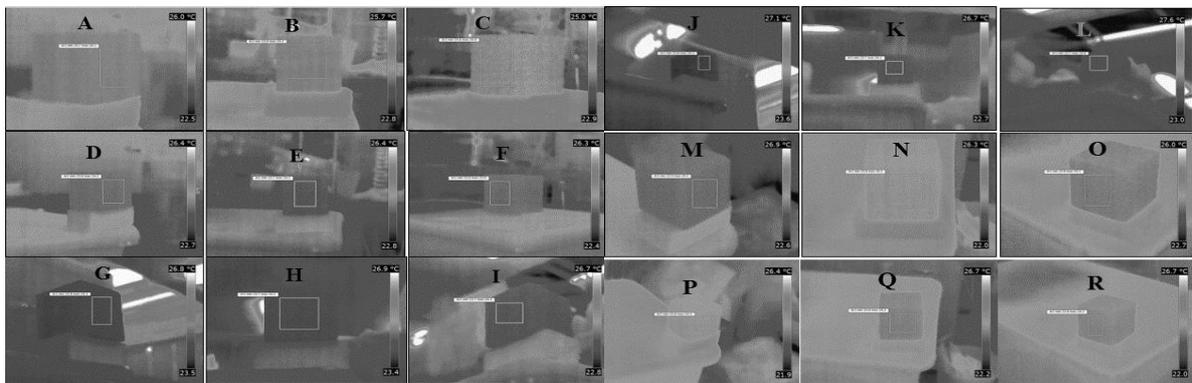
Figure 15: Images captured from different positions and angles

A total of 18 images were captured and assessed using QuickReport software to find the average temperature of the object's area at different positions. Figure 15 shows all the images captured, and Table 2 shows the average surface temperature for each image captured.

The object was set to room temperature and no external heating/cooling was applied to the object to have a linear surface temperature of the object. The total of 18 image's surface temperature, in table 2, show that the minimum temperature to be 23.8 °C, maximum of 24.1 °C, and the average of the total images to be 23.9 °C. This indicates the difference in temperature only showed a difference between the images to be ± 0.3 °C. Although these images were taken of the same object and same surface, it did show a small difference. It should be noted that when taking images from different positions, the surface visibility of the same area becomes different, change in shape and size. This makes a disadvantage when using the software QuickReport, since in the software only rectangles, points and lines can be chosen to identify the temperature of the pixels on or in the shape. In some of the images taken, the rectangles are different in shape; this might affect the average surface temperature of the chosen surface. Although it is the same object, some smaller areas might be affected by the environment, or these small areas can have slightly different texture that affects the emissivity value of the object.

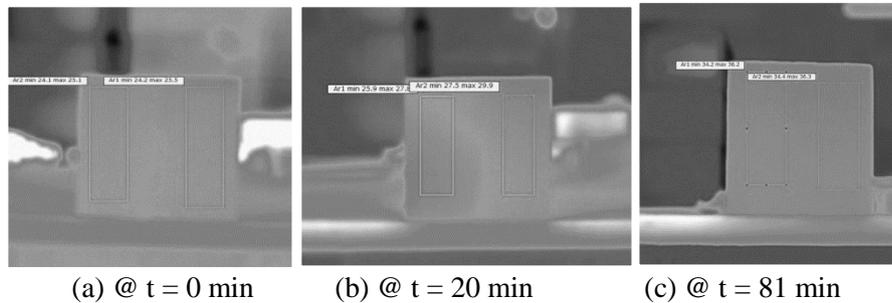
Figure 16: Cube tested

In Figure 16, one of the cubes at initial time = 0 min has been illustrated with another image with t = 20 min and a final time when both surfaces reached almost fully dry.

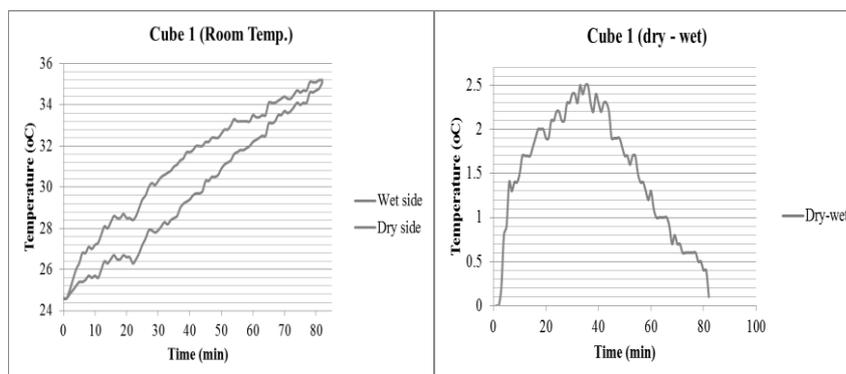
Figure 17: Cube 1 at room temperature

The results were obtained from all the images and assessed using the QuickReport to obtain the average area temperature of the “wet” side of the cubes (left side) and the average area temperature of the “dry” side of the cubes (right side). Each temperature was taken with its time captured and set in excel spread sheets. For each cube two graphs were plotted. One graph indicates the temperature curves of each side and the other to differentiate between the dry side and the wet side. The data was then plotted into graphs as seen Figures 17 - 20.

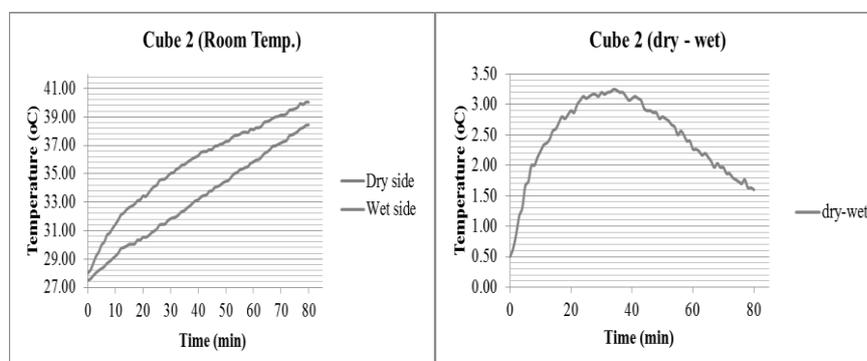
Figure 18: Cube 2 at room temperature

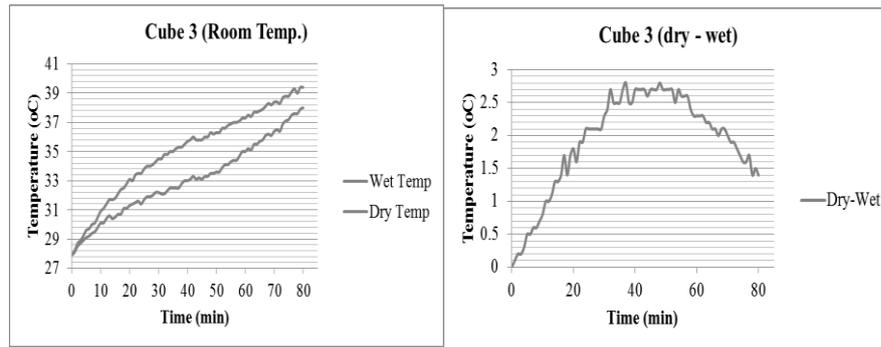
Figure 19: Cube 3 at room temperature

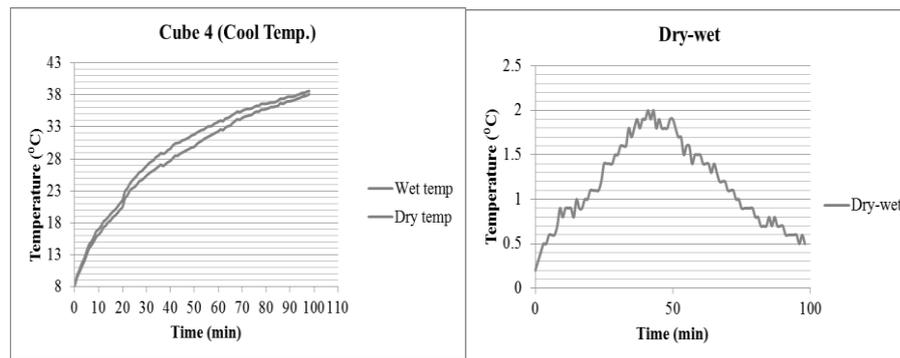
Figure 20: Cube 4 at cooler temperature

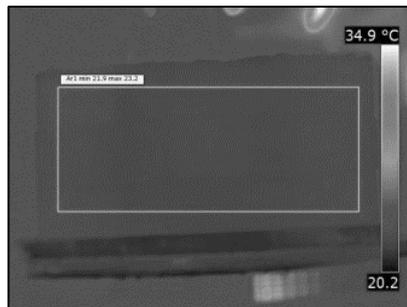
Figure 21: Masonry water tank with average surface temperature of 22.4 °C

The water tank was then led to leak for 24 hours where water was kept introduced to the tank. Also, to make it more realistic, a wet towel which was made wet with the same water temperature, was kept over the surface of the tank to have the whole surface wet. This was done to make the surface temperature to one temperature. To validate this, an image was taken the next day and showed this to be correct as seen in Figure 21.

To ensure which emissivity value has to be taken since there are two different materials, with the aid of the software QuickReport, when choosing the same area as seen in in figure 21, the emissivity values have each been inserted and showed that the difference in temperature is only ± 0.1 °C. However, in this case the emissivity value of 0.78 (lime) is chosen since the lime is the critical part of the suspected defect. Both active approaches have been assessed and resulted as follows.

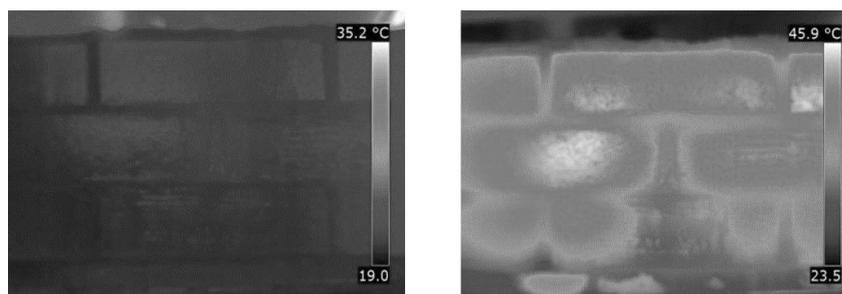
(a) @ time = 1 minute of heating (b) @ time = 30 minutes of heating

Figure 22: Difference of surface temperature after heating

The first captured image (at 1 minute after putting the lights on) and the last captured image are shown in Figure 22. The figures show that by heating up the surface it clears up much of the moisturized surface area.

For the first active approach, the halogen lights were used as a heat source to dry up the surface. From Figures 24 & 25 it can be seen, in a qualitative analysis, that after 30 minutes of heating up the surface, it noticeably showed where the defect is present. However, in this case the way the masonry tank was constructed, the moisturized part in the lime mortar did stay in the horizontal high upper and lower part of the tank. Discouraging in a quantitative way it has been clearly shown in figure 25 (left), that at all vertical joints are almost the same temperature at initial as expected. After heating up the surface for 30 minutes, in figure 25 (right), it has been visibly shown that the line of position 1 had the lowest temperature, which indicates the defect point. This is due that the water behind the heated-up surface is still at its original temperature, and when still leaking through the defect area, the moisture will not heat up as quickly as the un-defected areas by the heat of the light source. Also, Figure 26 clearly shows that position 1 is the defect spot at a certain time versus temperature.

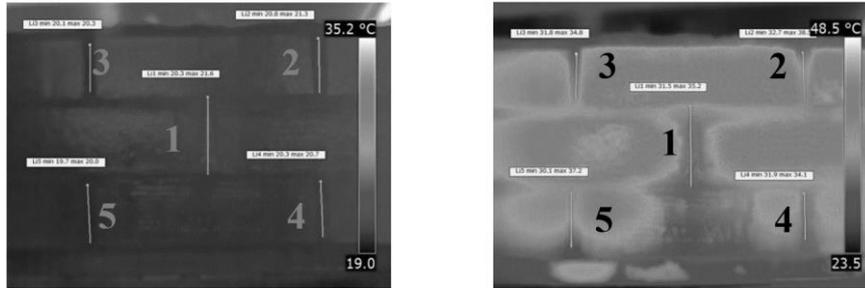
Figure 24: Indicating line segments.

The areas that had no defect clearly showed that it dried up, speaking in a qualitative manner. However, to evaluate it in a quantitative manner, line segments using the software QuickReport have been put over the vertical joints between the brick to differentiate between the 5 joints. This has been done in the same images from Figure 22. These lines in the images are presented in Figure 23.

The tank was constructed in such a way that the first leak should appear in the known vertical defect spot at the joint between the bricks. In Figure 24 this was demonstrated to be operational as expected. Although it is indicated that it started to leak after 5 minutes, this is however, not part of the analytical approach. It was proven when the emissivity value of 0.78 and 0.75 each were used as inputs in the QuickReport software to have almost the same surface temperature with a difference of ± 0.1 °C.

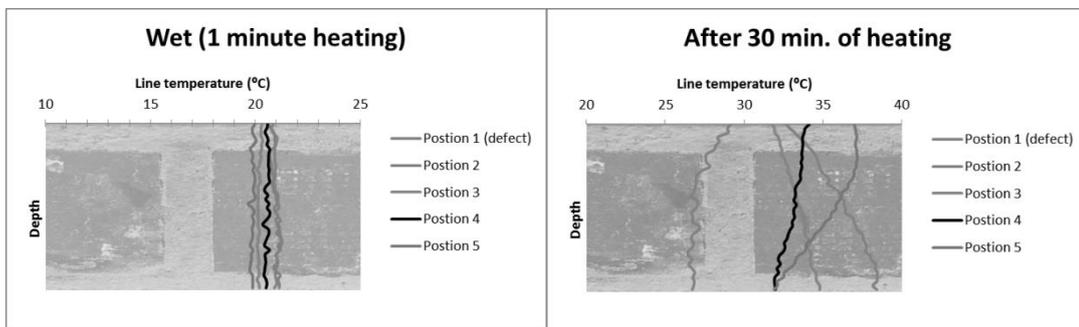
Figure 25: Line segments when heated with lights

Each of these lines indicated the temperature for each pixel along the line. These data have been transformed into excel spread sheets and presented in graphs. Figures 25 and 26 show these results.

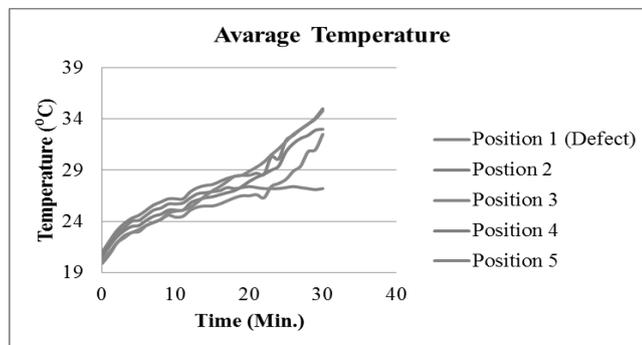
Figure 26: Average temperatures at every minute

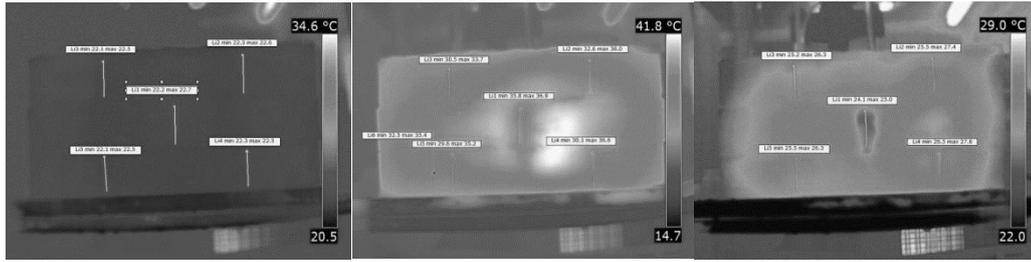
(a) Fully wet (t = 0 min) (b) After heating (t = 4 min) (c) Cooling (t = 10 min)

Figure 27: Three phases using hot air gun

In Figure 27 the images are being shown of all the three phases.

In the second active approach using the hot air gun, almost the same first steps were taken when using the halogen lights. However, in this technique three images have been taken to differentiate and get accurate results. From figure 27 (a), its vertical line temperature results are presented in figure 28 (left). It can be undoubtedly seen that at all positions the temperatures were similar at initial (before heating) in figure 27 (a). The surface was then dried up (figure 27 (b)) using the hot air gun within just 4 minutes, and the results at each position has been plotted in figure 28 (right) which gave a disturbing difference in temperature at each position from 33 – 38 °C. However, just after 6 minutes of cooling, it showed very explicit results in figure 29 (left). The defect position 1 was very well noticed from the results. Also, differentiating between the images in the three different phases of figure 27, it is very well shown, in a qualitative approach where the defect point is after cooling down in just 10 minutes. Figure 29 (right) showed a clear view of the time and temperature relationship as expected and showed clearly that the defect spot is to be found at position 1.

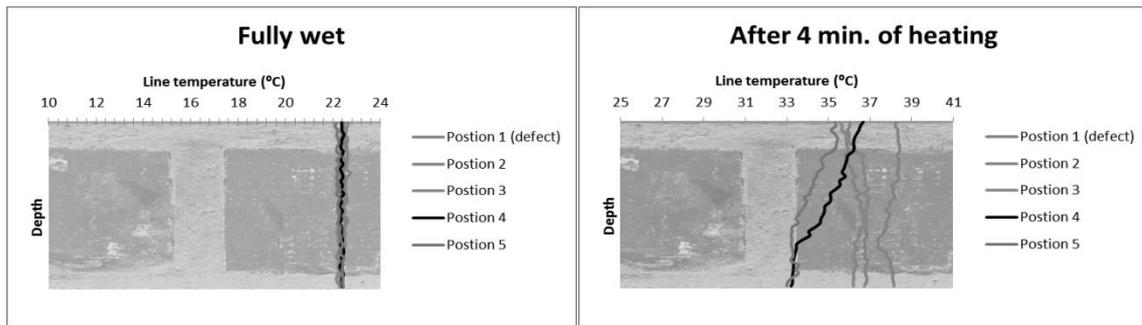
Figure 28: @ t = 0 min (left) and t = 4 min. (right)

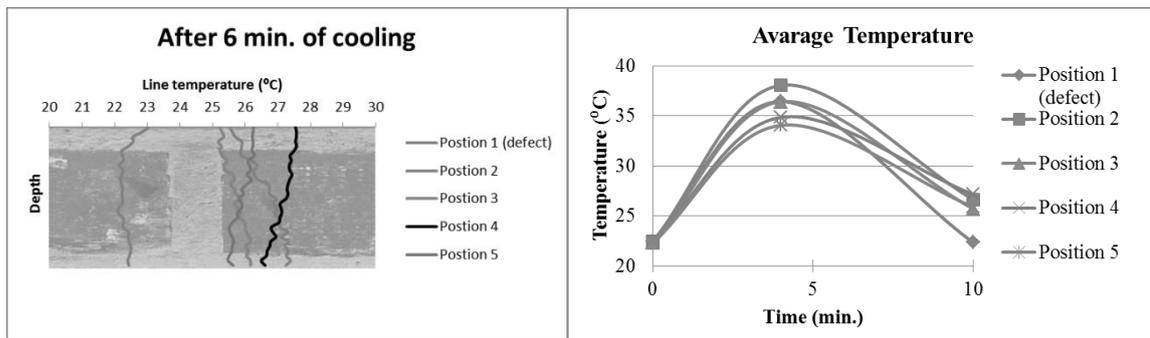
Figure 29: After cooling @ t = 10 min (left), Average temperatures at every minute (right)

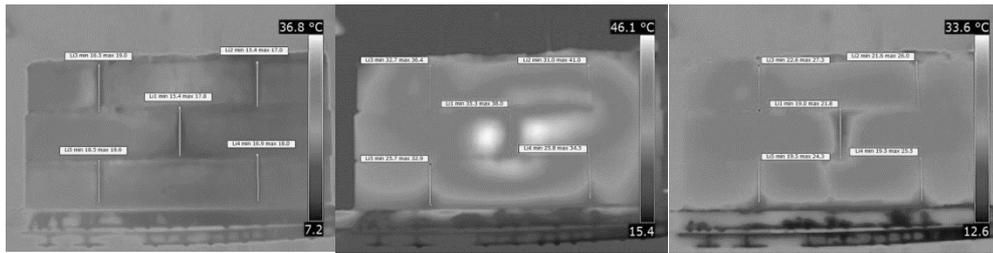
(a) Fully wet (t = 0 min) (b) After heating (t = 4 min) (c) Cooling (t = 10 min)

Figure 30: Three phases using hot air gun (Cool water)

However, to evaluate the process of using a hot air gun for detecting masonry defects further, instead of room temperature water, cold water was introduced in the masonry water tank to see if there would be any significant difference in the results other than having the temperatures lower. The procedure was carried out the same as the previous procedure and the results are shown in the following figures.

The same approach was then re-evaluated with cooler water. It was expected to take a longer time to do the same three phases; however, it took the exact same time to get good results to detect the defect point as seen in the figures 30 – 33. Comparing the two active approaches, it can be certainly known that using the hot air gun is a much faster technique for detecting the defect position in this case. The second technique is done 20 minutes quicker than the first technique.

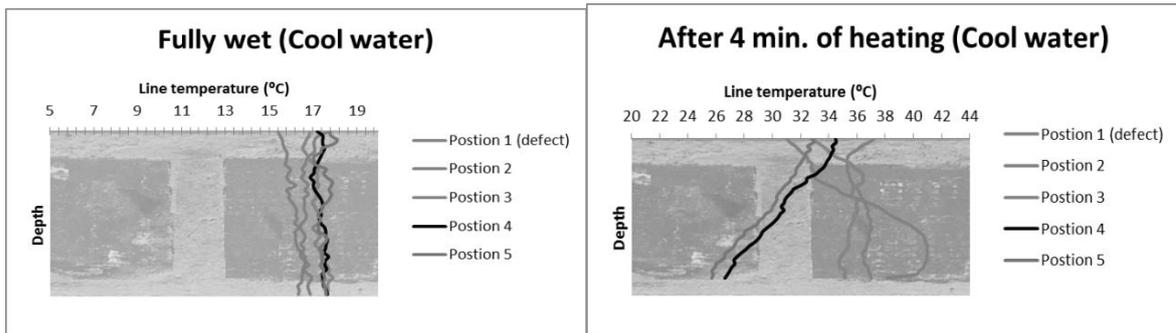
Figure 31: Line segments @ t = 0 (Cool water) (left) and @ t = 4 min (Cool water) (right)

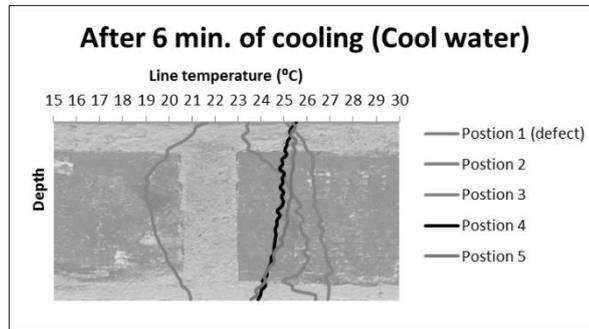
Figure 32: After cooling line segments at t = 10 min (Cool water)

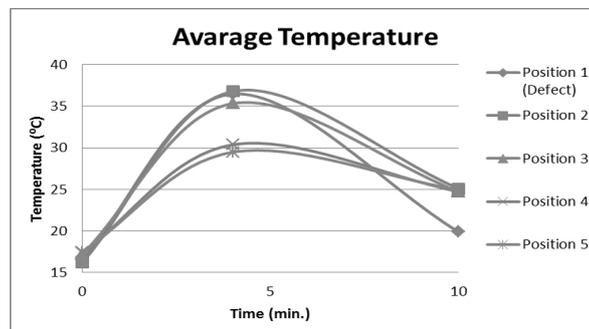
Figure 33: Average temperatures at every minute (Cool water)
